# Slope Stability Analysis and Remediation Measures in the Three Gorges Reservoir Area: A Case Study of a Soil–Rock Mixed Slope in Zhongxian County

**Abstract:** This study investigates a soil–rock mixed slope in the Dongxi Community resettlement area of Zhongxian County, Three Gorges Reservoir region, based on field investigation and the strength reduction method (SRM) to evaluate its natural stability and verify the effectiveness of anti-slide piles reinforcement. The slope is 16–18 m high, with upper fill and silty clay overlying sandstone and mudstone. The fill roadbed at the crest has undergone a collapse zone of approximately 20 m×3 m, accompanied by cracking and retaining wall damage. Under natural conditions, the factor of safety (Fs) is 1.06 and the maximum displacement is 4.82 cm, indicating a basically stable state with insufficient reserve, while plastic deformation concentrates near the steep crest section. After installing 14 rock-socketed anti-slide piles (20 m in length, 5 m spacing, 8 m embedment into bedrock), Fs increases to 1.42 and displacement drops to 0.006 cm, representing a 34.0% improvement and a 99.9% reduction, respectively; both the localized deformati

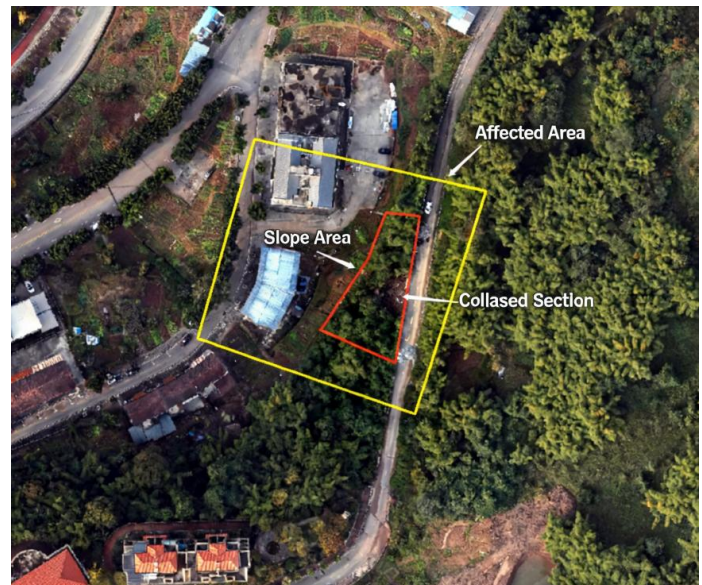
**Figure 1 | Schematic diagram of the distribution location of the study slopes**

The slope of the relocation area in Dongxi Community, Dongxi Town, Zhongxian County was formed by the excavation for urban relocation construction. It is a rock and soil slope located behind the still-rebuilding houses on Jiangwei Road in Dongxi Community. The slope is generally linear in shape, with a slope direction of approximately  $275^\circ$ . The slope length is about 50 meters, and the slope height is 16 to 18 meters. According to the "Technical Code for Slope Engineering in Buildings" (GB 50330-2013), this slope belongs to grade II to III and has a safety level of grade II. It should meet the corresponding stability requirements during the design service life. The slope area is approximately 1,060 square meters. The slope is steep at the top and gentle at the bottom, with an upper slope angle of about  $80^\circ$  to  $90^\circ$  and a lower slope angle of about  $30^\circ$ . The top of the slope is a road, and the bottom is a residential area and vegetable field. It has the characteristic that the load at the top of the slope and the affected area of the residential area at the bottom are large. The distribution location of the slope is shown in Figure 1.

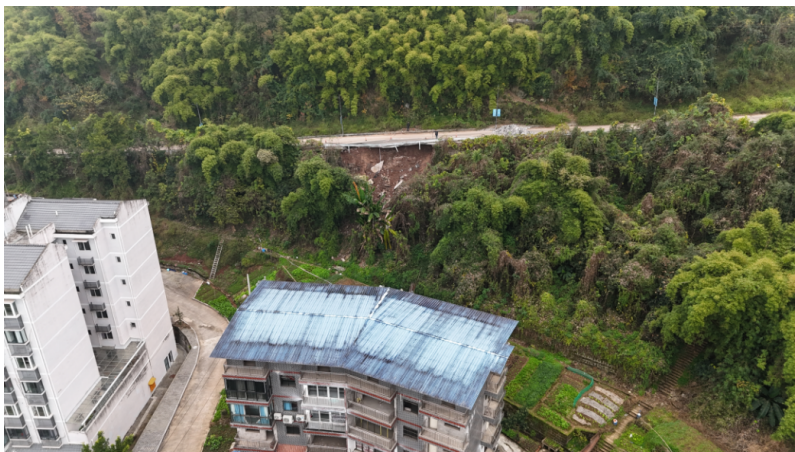
Figure 2 | Full view of the slope site

The uniformity of the fill roadbed at the top of the slope is poor. It is loose to slightly dense, and the contact conditions between the upper soil layer on the slope and the underlying bedrock are complex, which is the main weak part controlling the slope deformation. Field investigation shows that the fill roadbed at the top of the slope has already collapsed for about 20 meters in length and about 3 meters in width, causing pavement cracking and damage to the outer retaining wall; under the continuous rainfall, the slope may further undergo soil deformation and extend deeper. The overall view of the slope site is shown in **Figure 2**, and the collapse of the top roadbed and pavement deformation are shown in **Figure 3**.

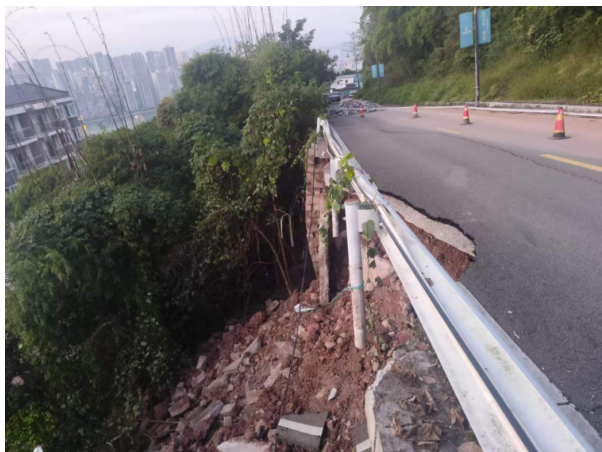
Figure 3 | Slope top roadbed collapse and pavement deformation
